FLIGHT TEST EVALUATION OF FOLDING SIDEWALL EXPANDABLE TIRES ON THE C-131B AIRCRAFT

**TECHNICAL REPORT ASD-TR-73-1**

**JANUARY 1973**

4950TH TEST WING
AIR FORCE SYSTEMS COMMAND
WRIGHT-PATTERSON AIR FORCE BASE, OHIO

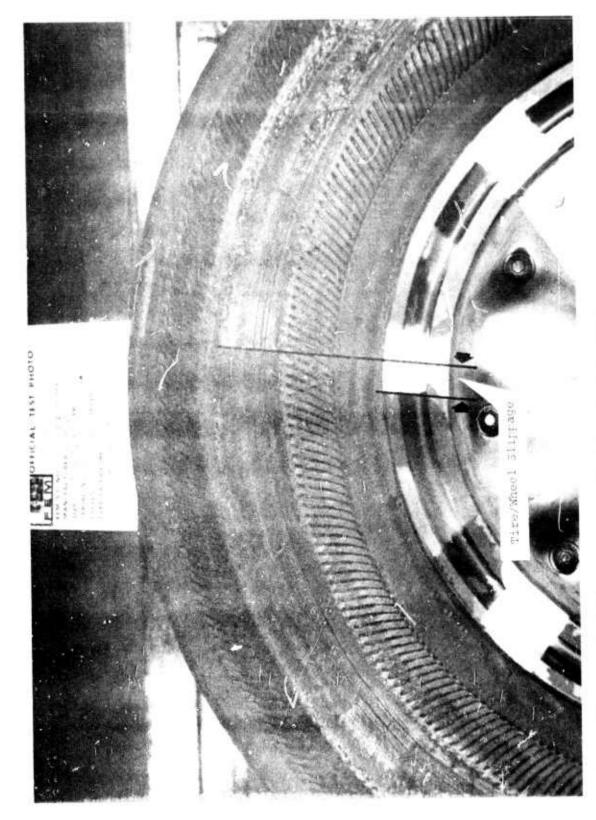
The outboard tires on both main landing gear exhibited no evidence of failure or deficiency. However, when reinflated, these tires exhibited poor air retention qualities. The applicable specification, Reference 2, allows a maximum pressure loss of only 4 psi in a 24-hour period. Contained air losses for both outboard tires were greater than 16 psi in a 24-hour period. Figures 16 and 17 show the condition of the left main landing gear outboard tire, s/n 51-0035-17, upon reinflation. These figures also show the small amount of slippage which occurred between the tire and the wheel.

Figure 17. Close-up Of Outboard Sidewall Of Tire No N51-0035-17 After a High Speed Run-flat Rollout. Tire Is Inflated.
